JARGY CO., LTD.

Test Report

Model : [CBL-D302MBSWB-20m](#)
Camera Brand Name : [Toshiba Teli](#)

Date : 2018/7/9

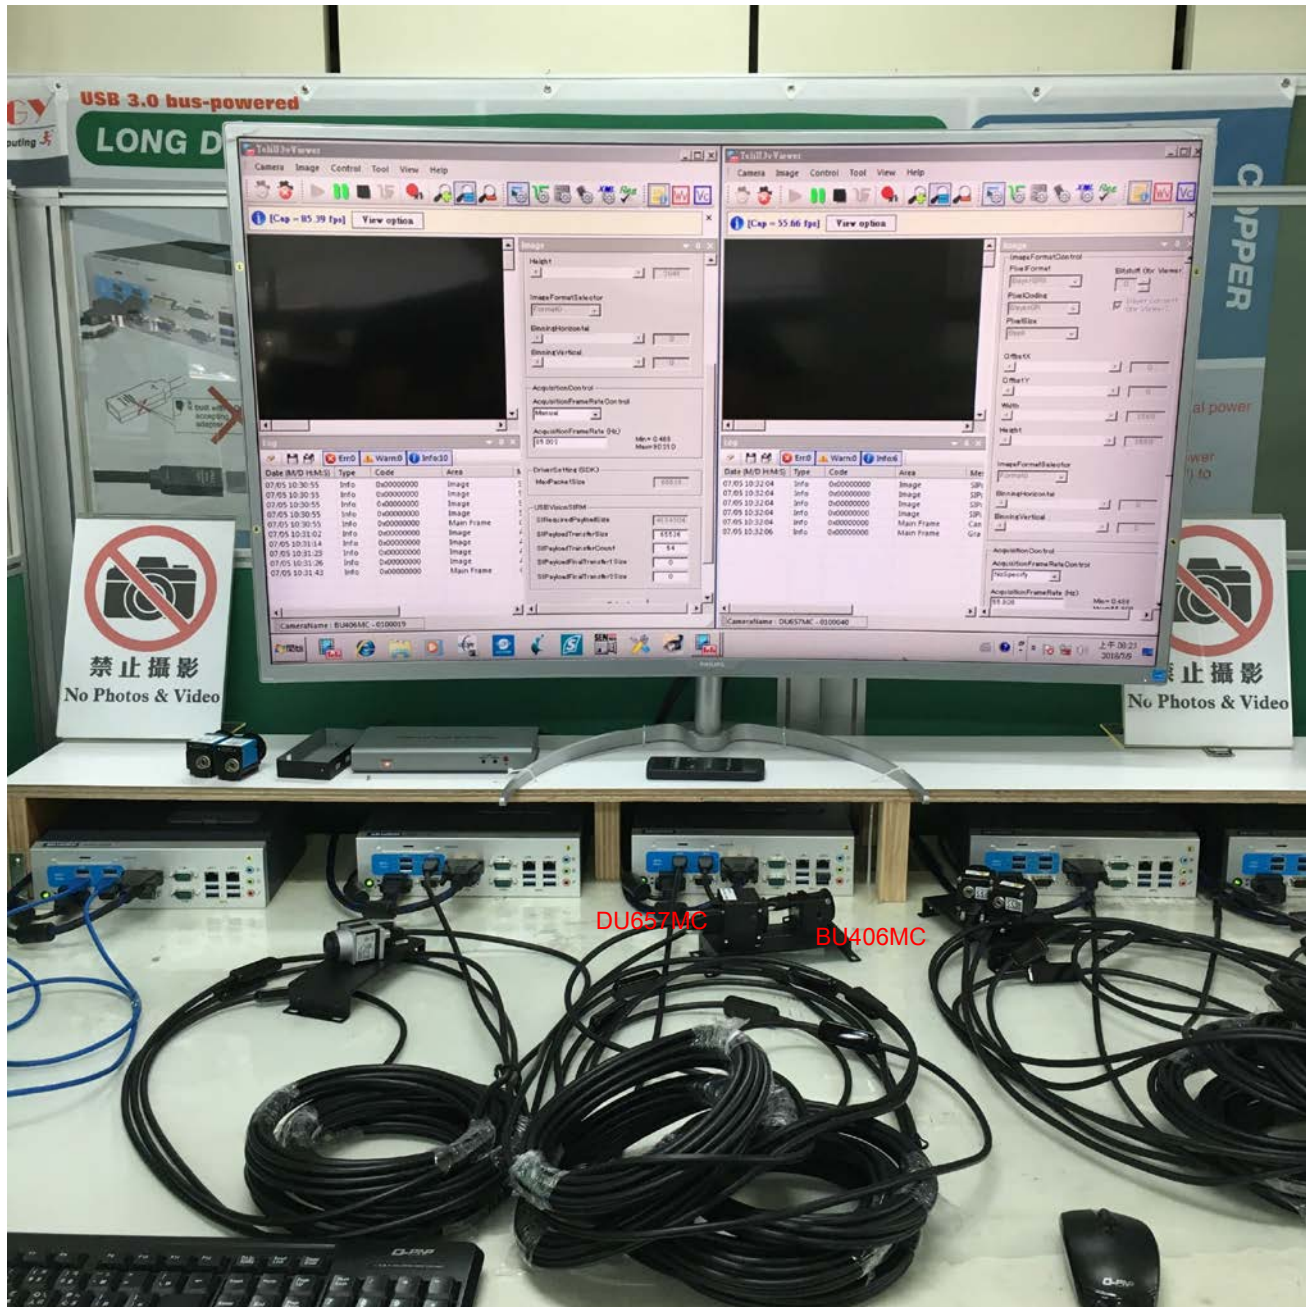
Tested Camera : [BU406MC](#) (2048 x 2048, 4MP, 90fps, 377MB/s) + [DU657MC](#) (2560 x 2560, 6.5MP, 55fps, 357MB/s)

Tested time : [69h](#)

[Cap = 84.89 fps] View option

AcquisitionFrameRate (Hz): 85.022

Bandwidth(MB/s):351

CameraName : BU406MC - 0100019

[Cap = 55.34 fps] View option

AcquisitionFrameRate (Hz): 55.308

CameraName : DU657MC - 0100040
